Intervention Report

<u>Sender</u> : iUMTEK 1 Chemin de la Porte des Loges 78350 Les Loges-en-Josas France

Recipient : Nuclear Research Center – Negev P.O. Box 9001 Beer Sheva 84190 Israel

Instrument model : TX 1000

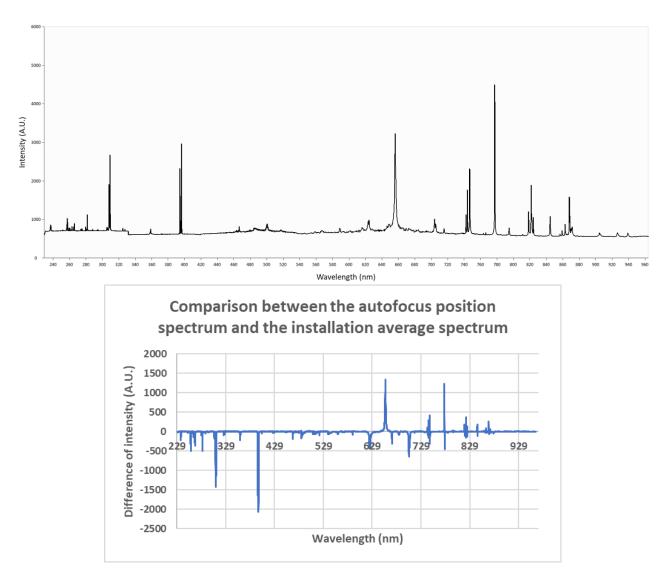
Signal obtained :

The analysis shows global loss of intensity up to 2000, compared to the installation acceptance average spectrum, except for the wavelengths of the ambient air H, N and O which is normal due to the incorrect focal setting.

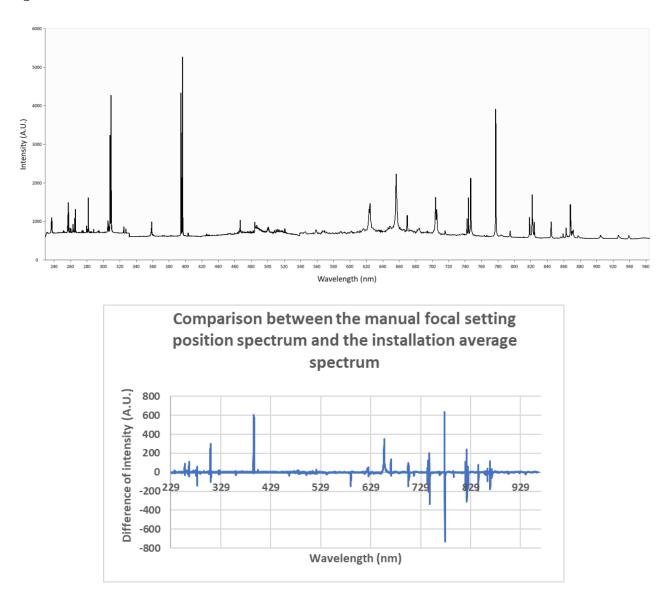
<u>Signal obtained</u> :

The spectrum obtained shows an intensity of the same order than the installation acceptance average spectrum. Therefore:

- a) This proves that the laser and spectrometers optical path are correctly set at this position.
- b) The pointer 2 is not correctly set and the pointer 1 and viewing camera have a little shift.
