Glitched on Earth by Humans: A Black-Box Security Evaluation of the SpaceX Starlink User Terminal

Lennert Wouters

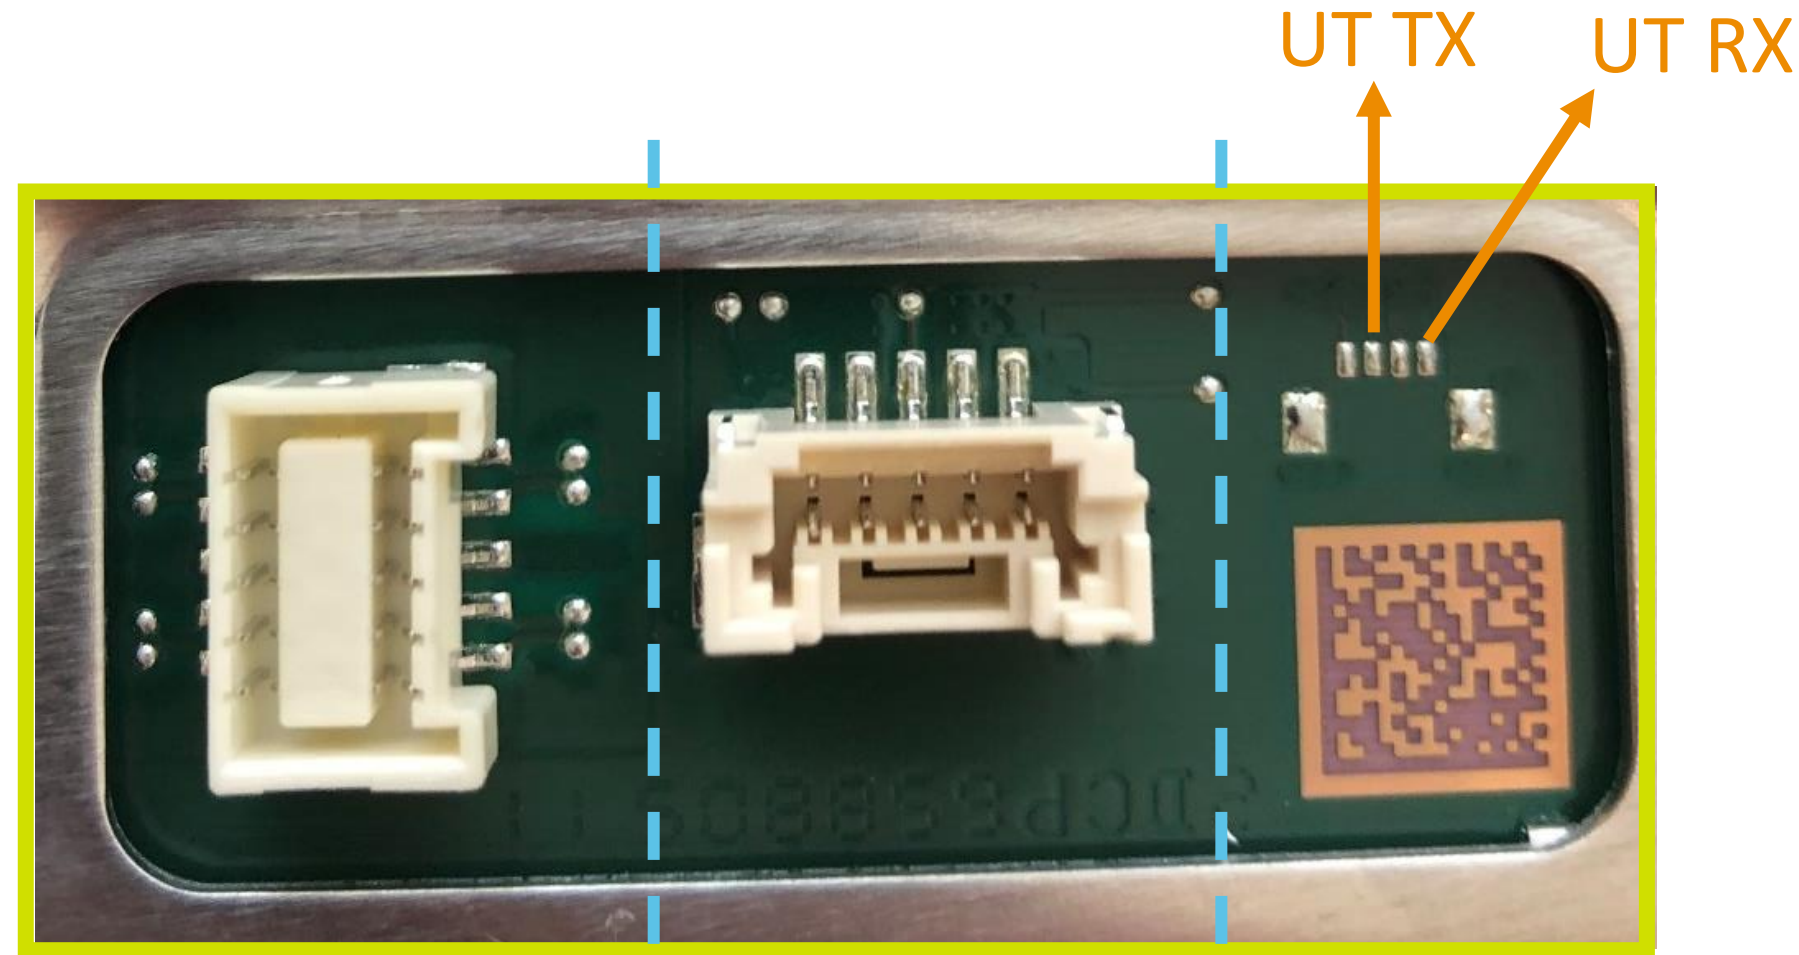
Accessible connectors on V2*

ethernet + power

JST BM10B-ZPDSS-TF(LF)(SN)

motors

JST BM05B-ZESS-TBT(LF)(SN)

UART

*V1 hardware had an extra connector, V3 does not have easily accessible connectors

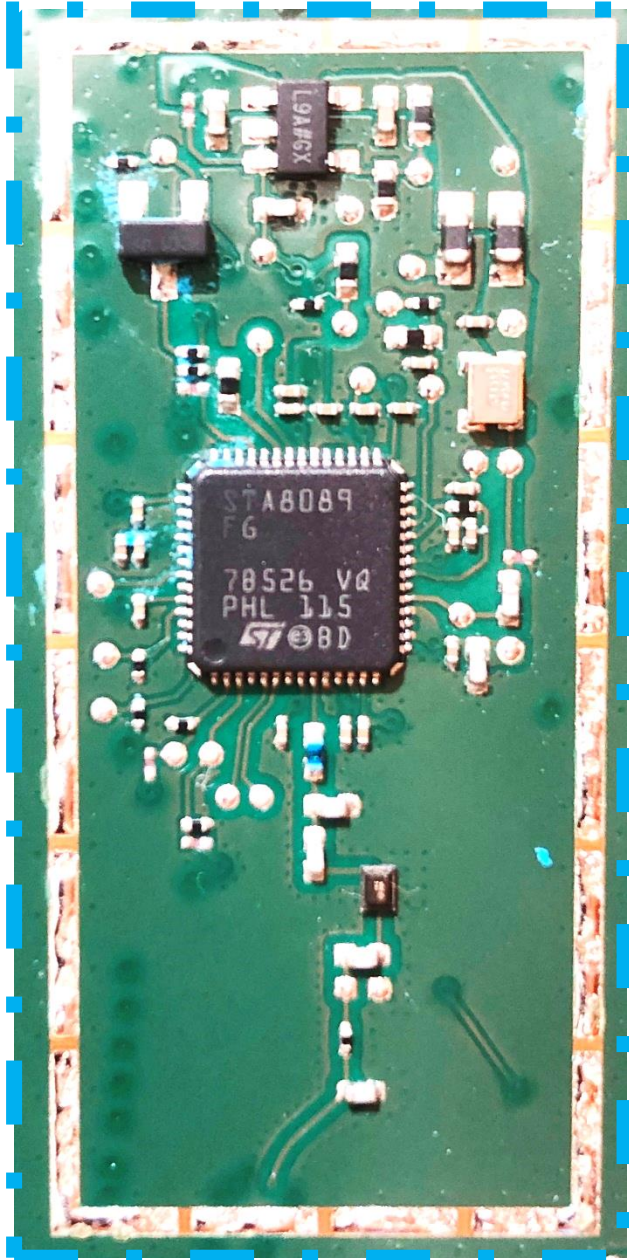
GPS receiver

STM STA8089

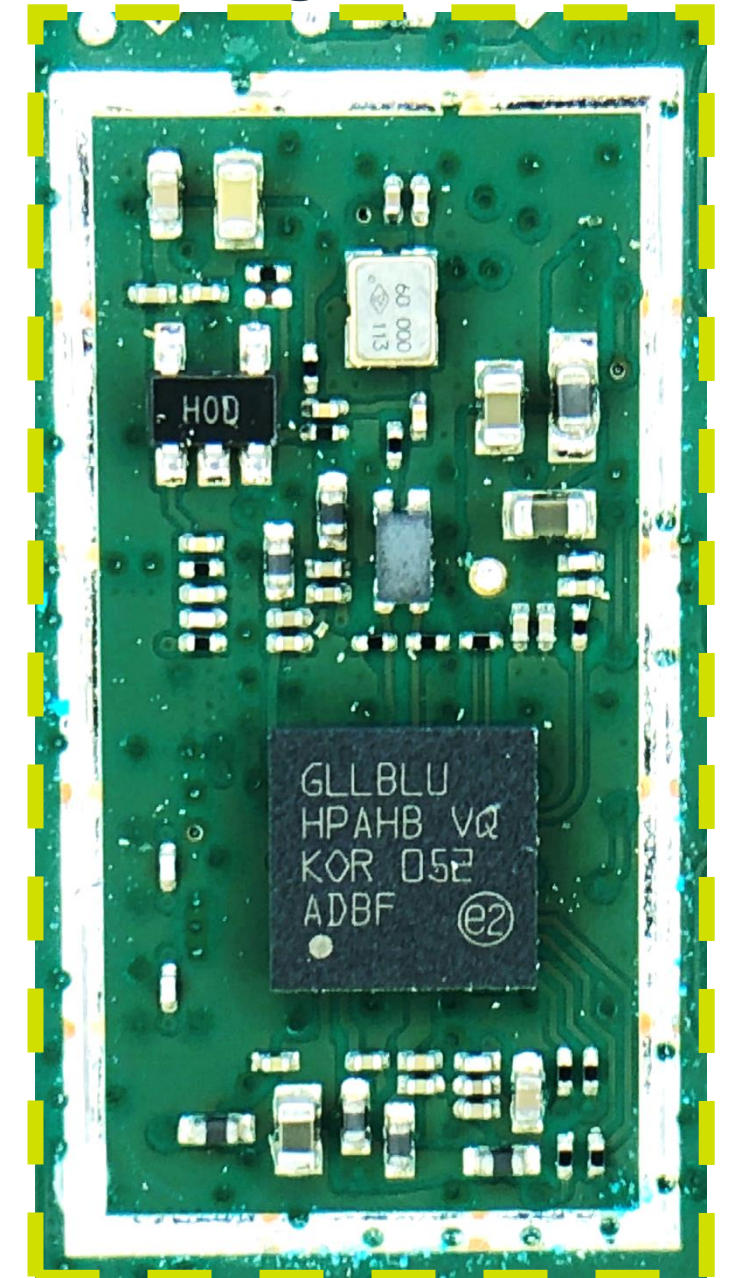
Clock generation

GLLBLU

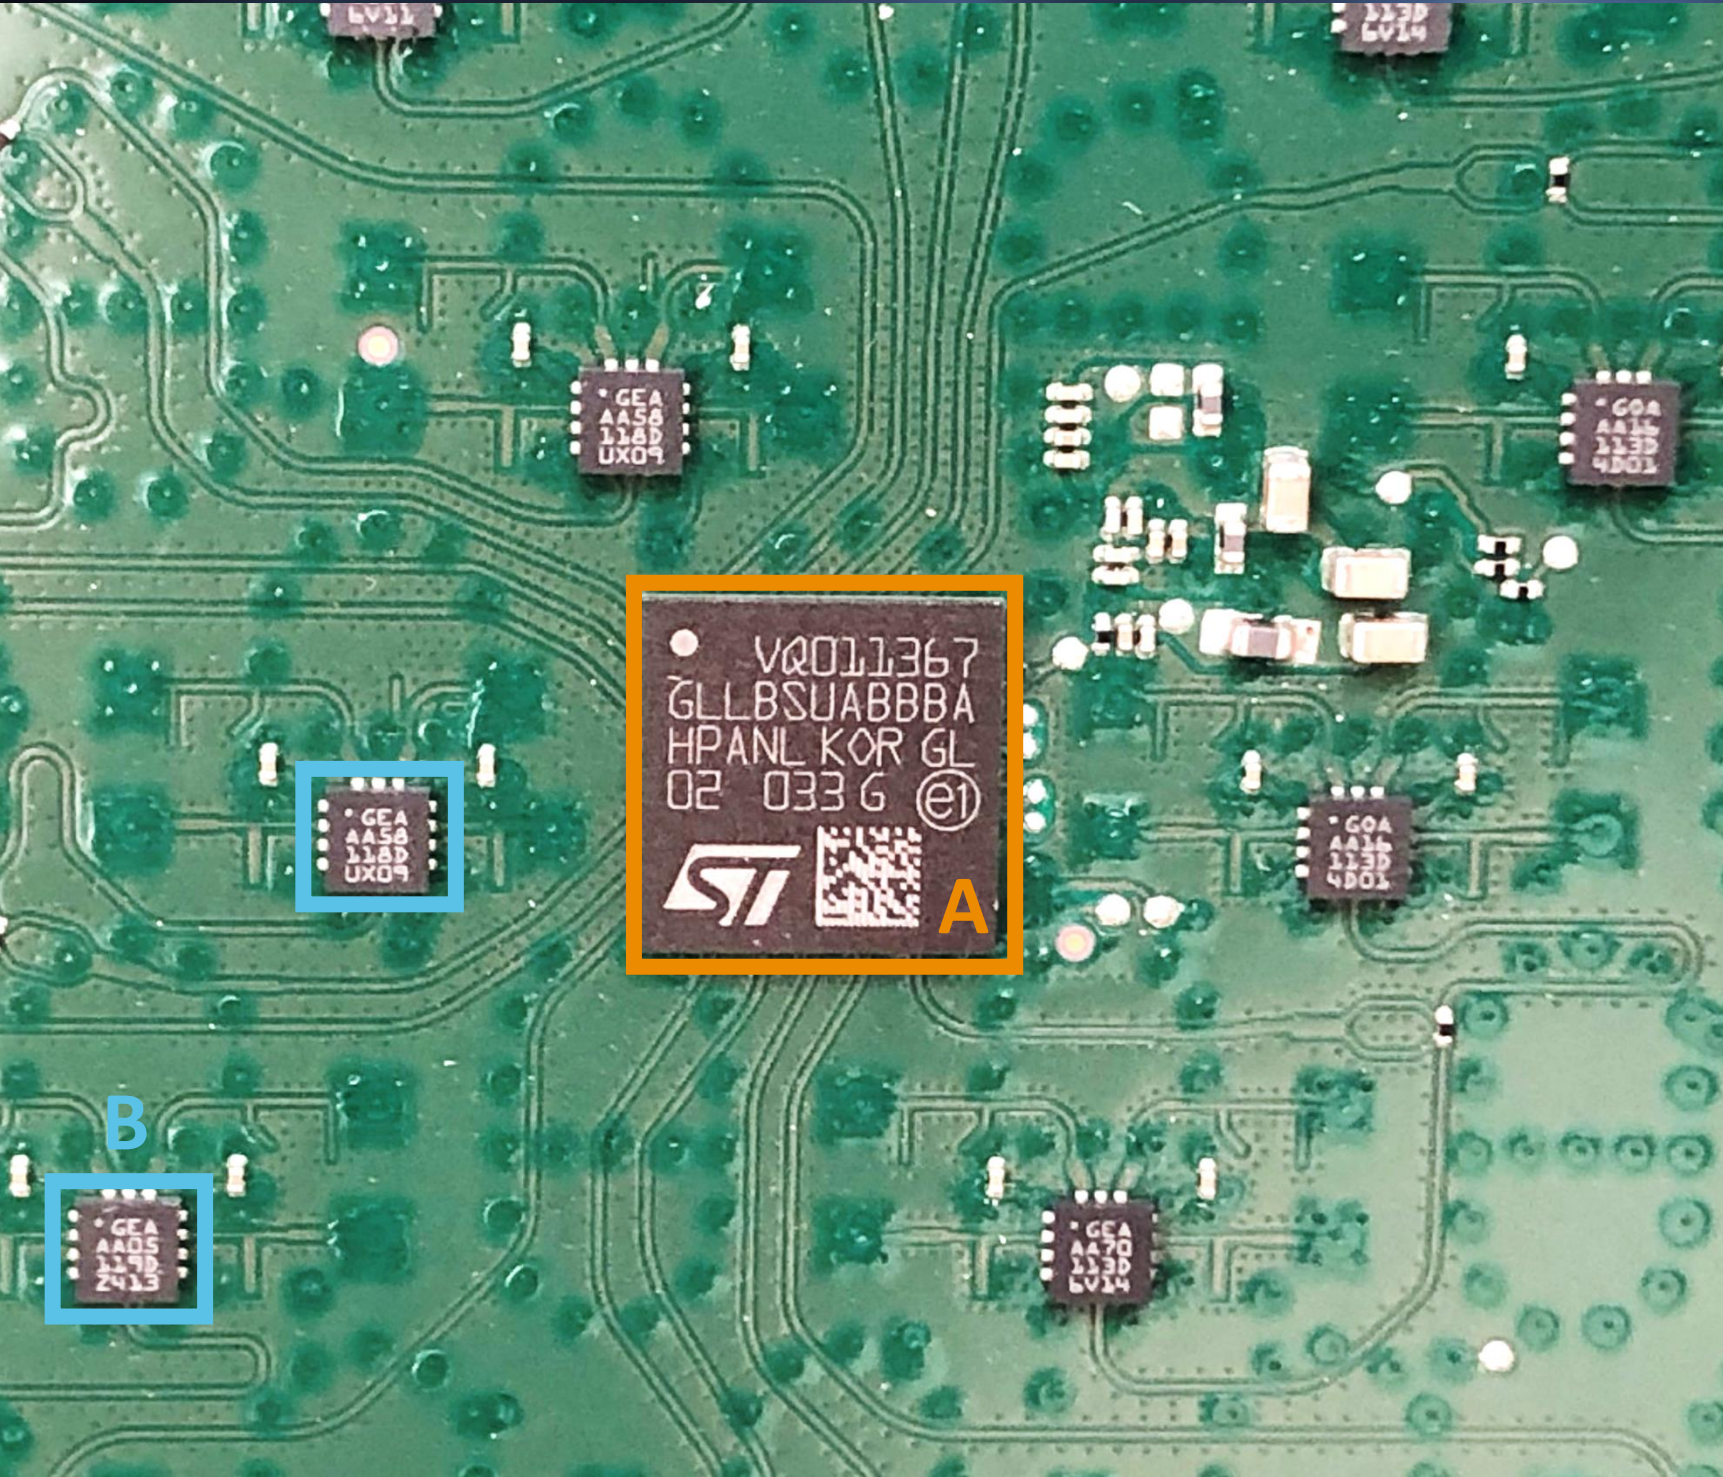
RF Components

- (A) Digital BeamFormer (DBF)
 - STM GLLBSUABBBA
 - Codename: **SHIRAZ**
- (B) Front-End Module (FEM)
 - Codename: **PULSAR(AD)**
- V2 hardware and up:
 - 1 DBF → 16 FEMs

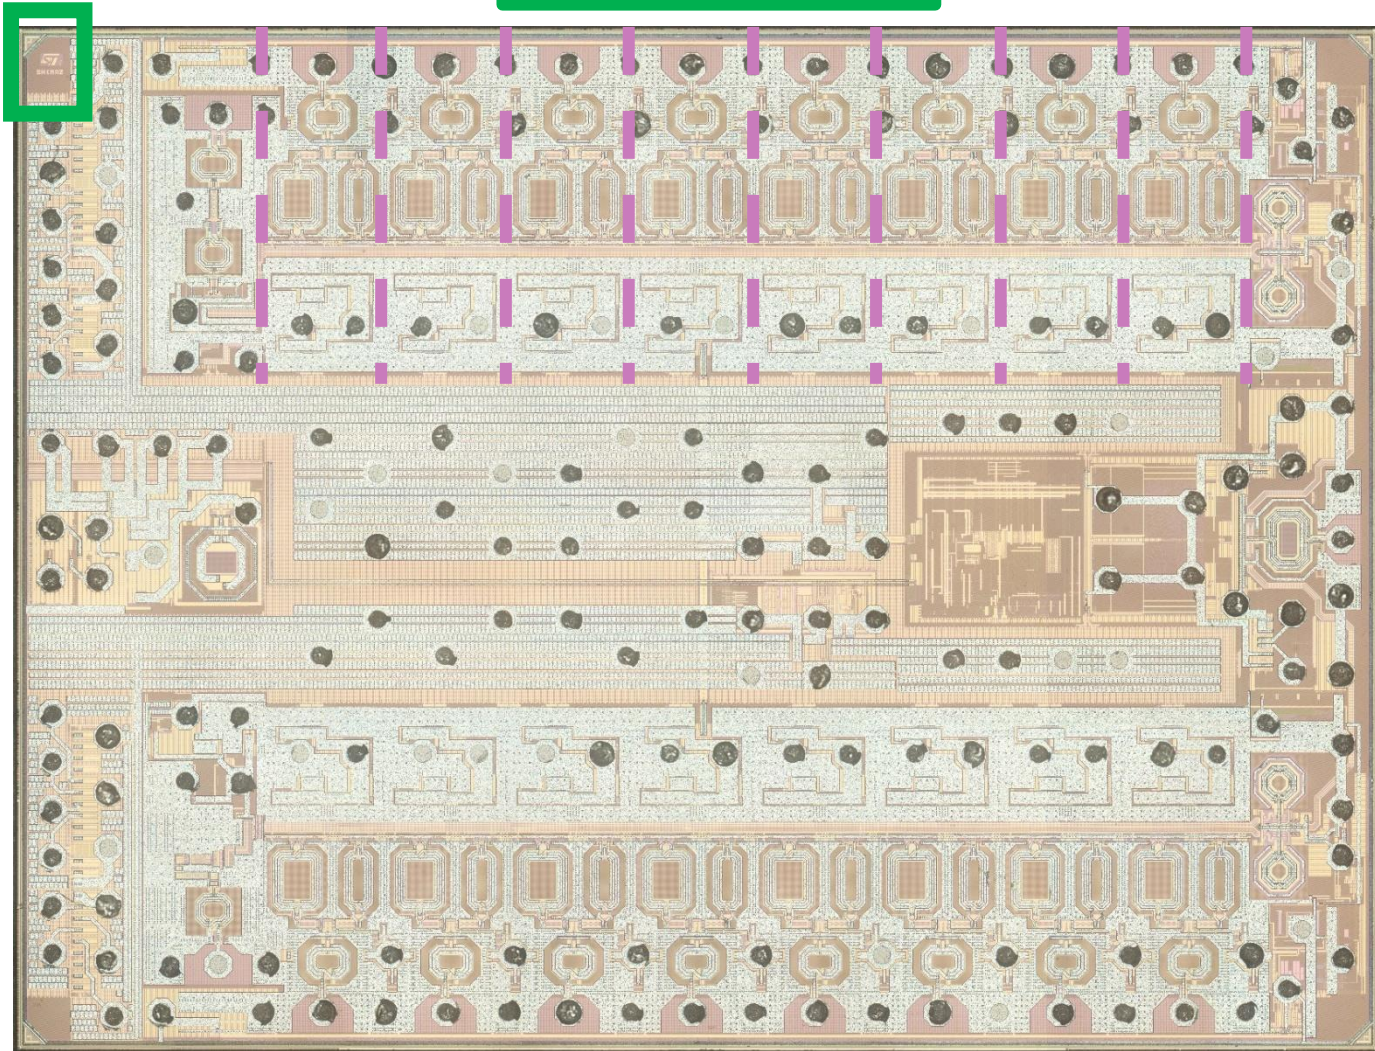
SHIRAZ

siliconpr0n.org/archive/doku.php?id=mcmaster:spacex:gllbsuabbba-shiraz

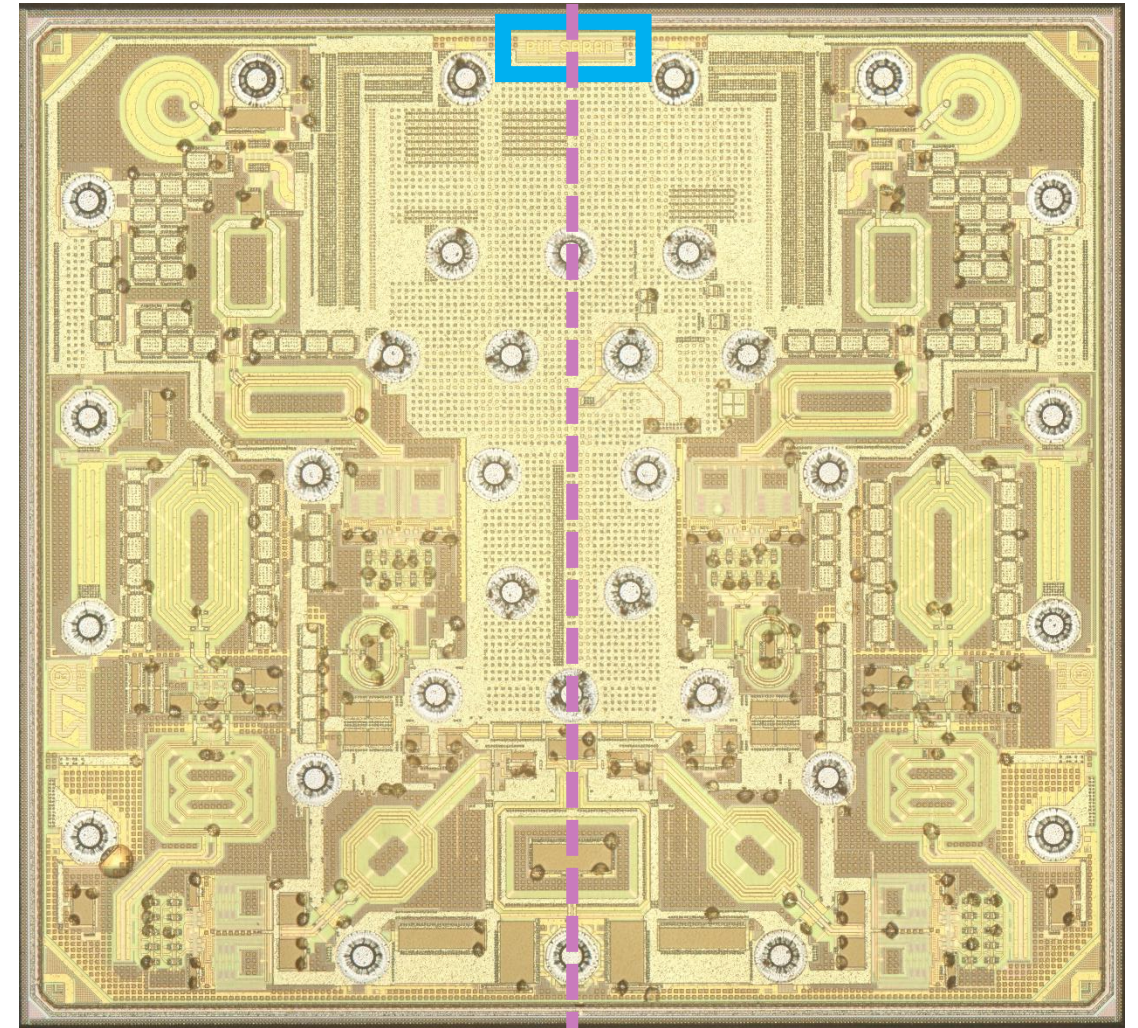
PULSARAD

[id=mcmaster:spacex:gea-aa12-109d-tg02-pulsarad](https://siliconpr0n.org/archive/doku.php?id=mcmaster:spacex:gea-aa12-109d-tg02-pulsarad)

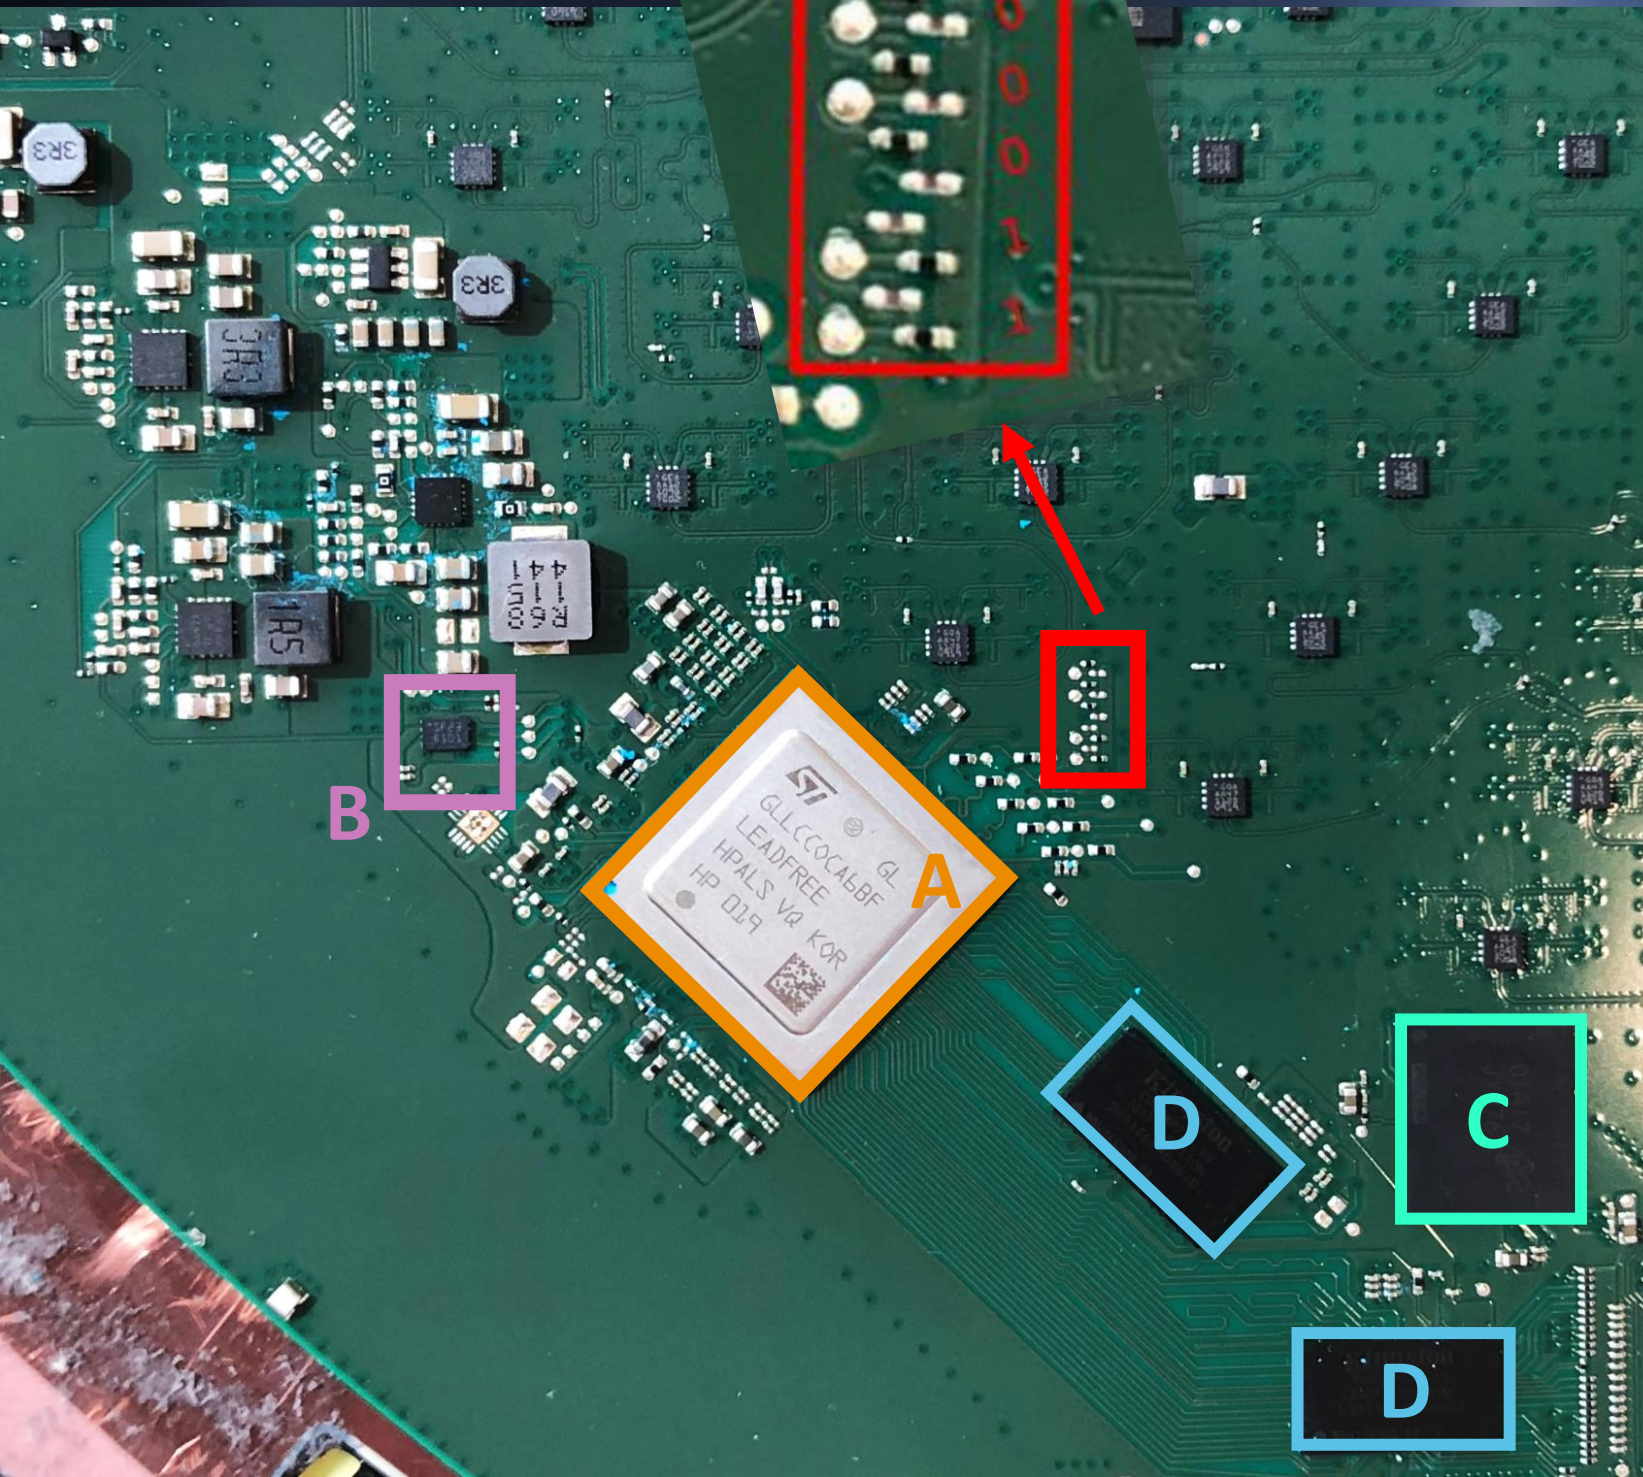
- (A) System-on-Chip
 - Custom quad-core ARM Cortex-A53
 - ST Microelectronics
 - GLLCCOCA6BF (cut 3?)
 - GLLCCODA6BF (cut 4?)
 - Codename: **CATSON**
- (B) Secure Element
 - STM STSAFE-A110
- (C) 4GB eMMC
- (D) 2 x 4Gbit DDR3

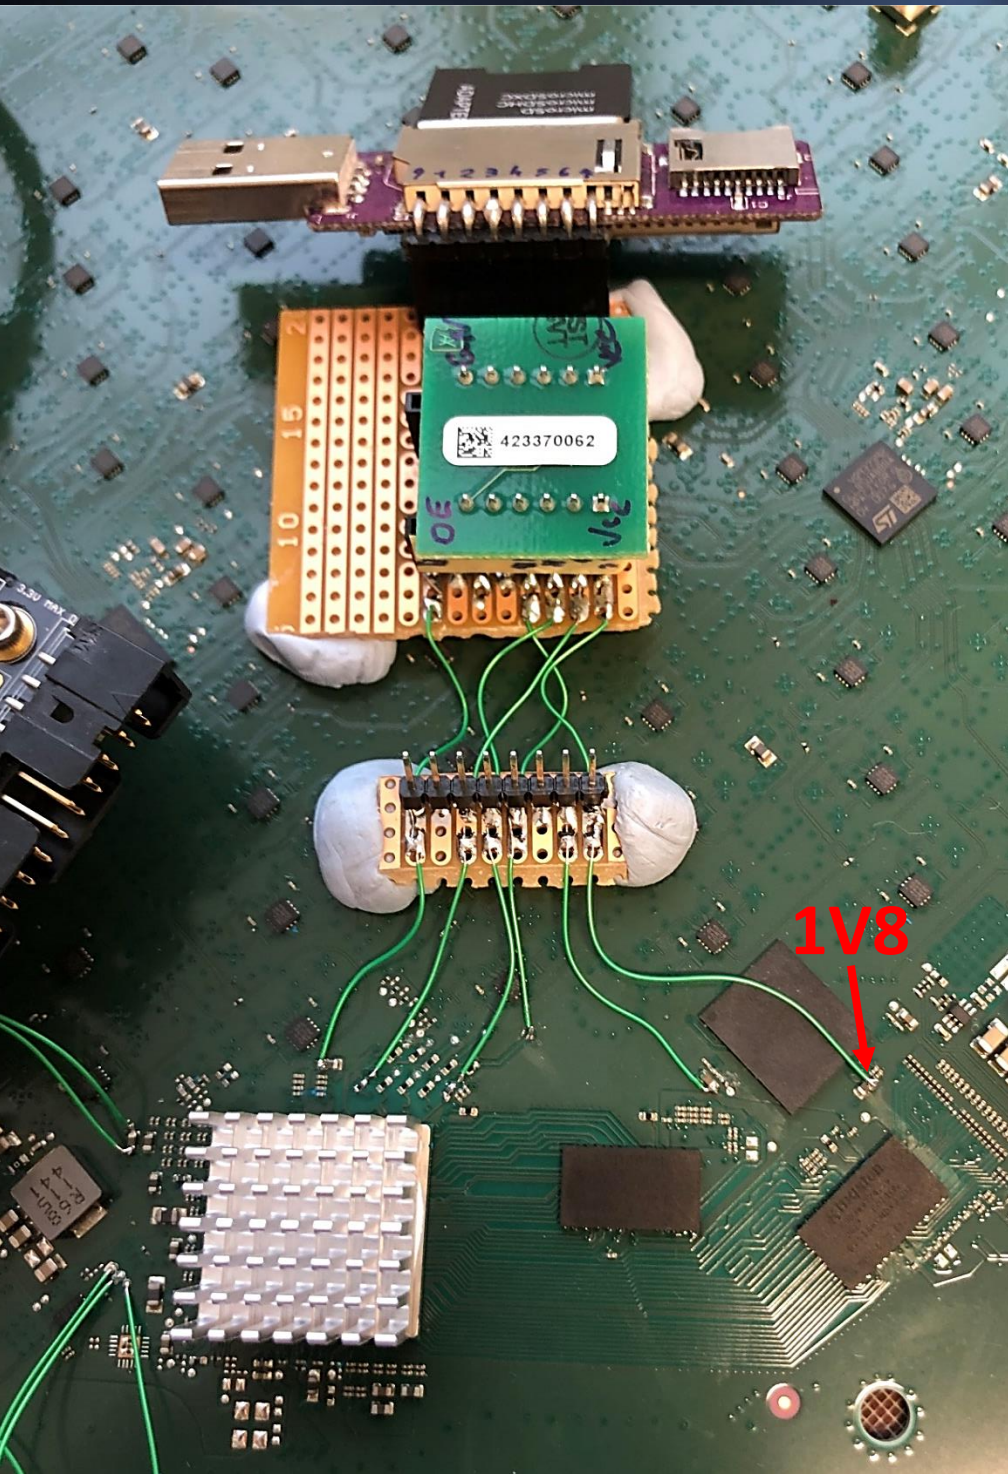
Reading eMMC in-circuit

SD card reader

TXS0202EVM
Level shifter

← What I did

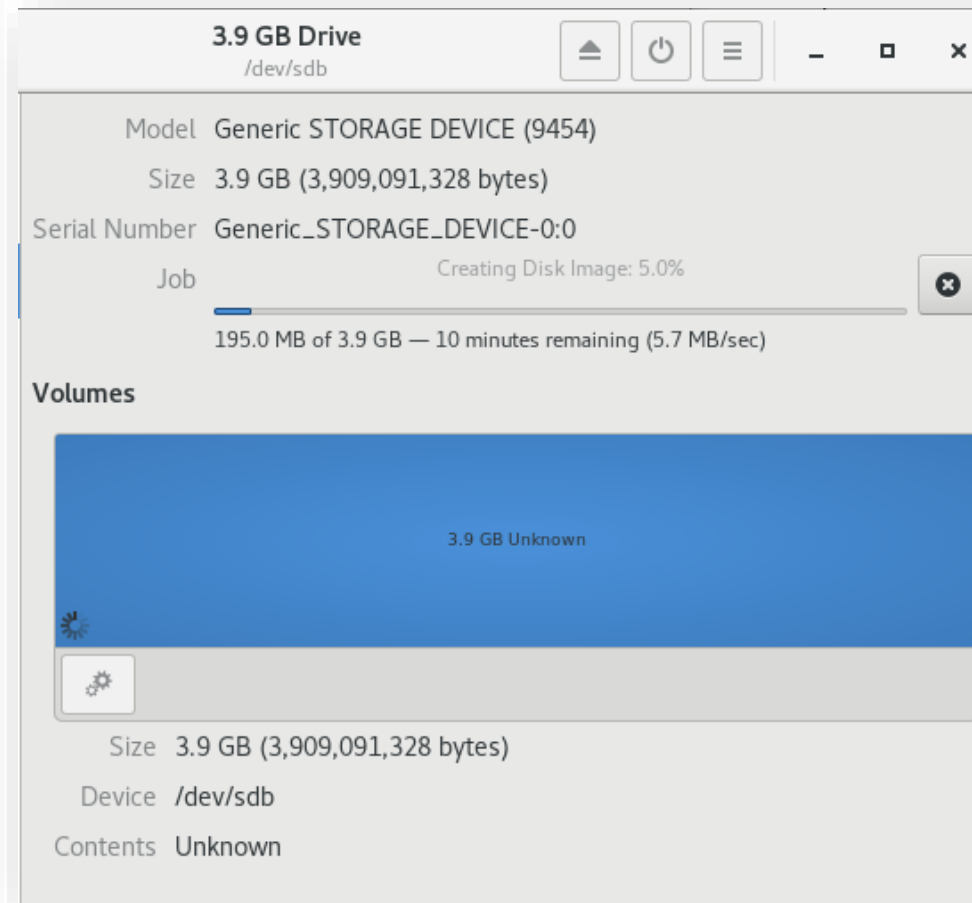
What I recommend →

Low Voltage eMMC Adapter
by
eXploitee.rs

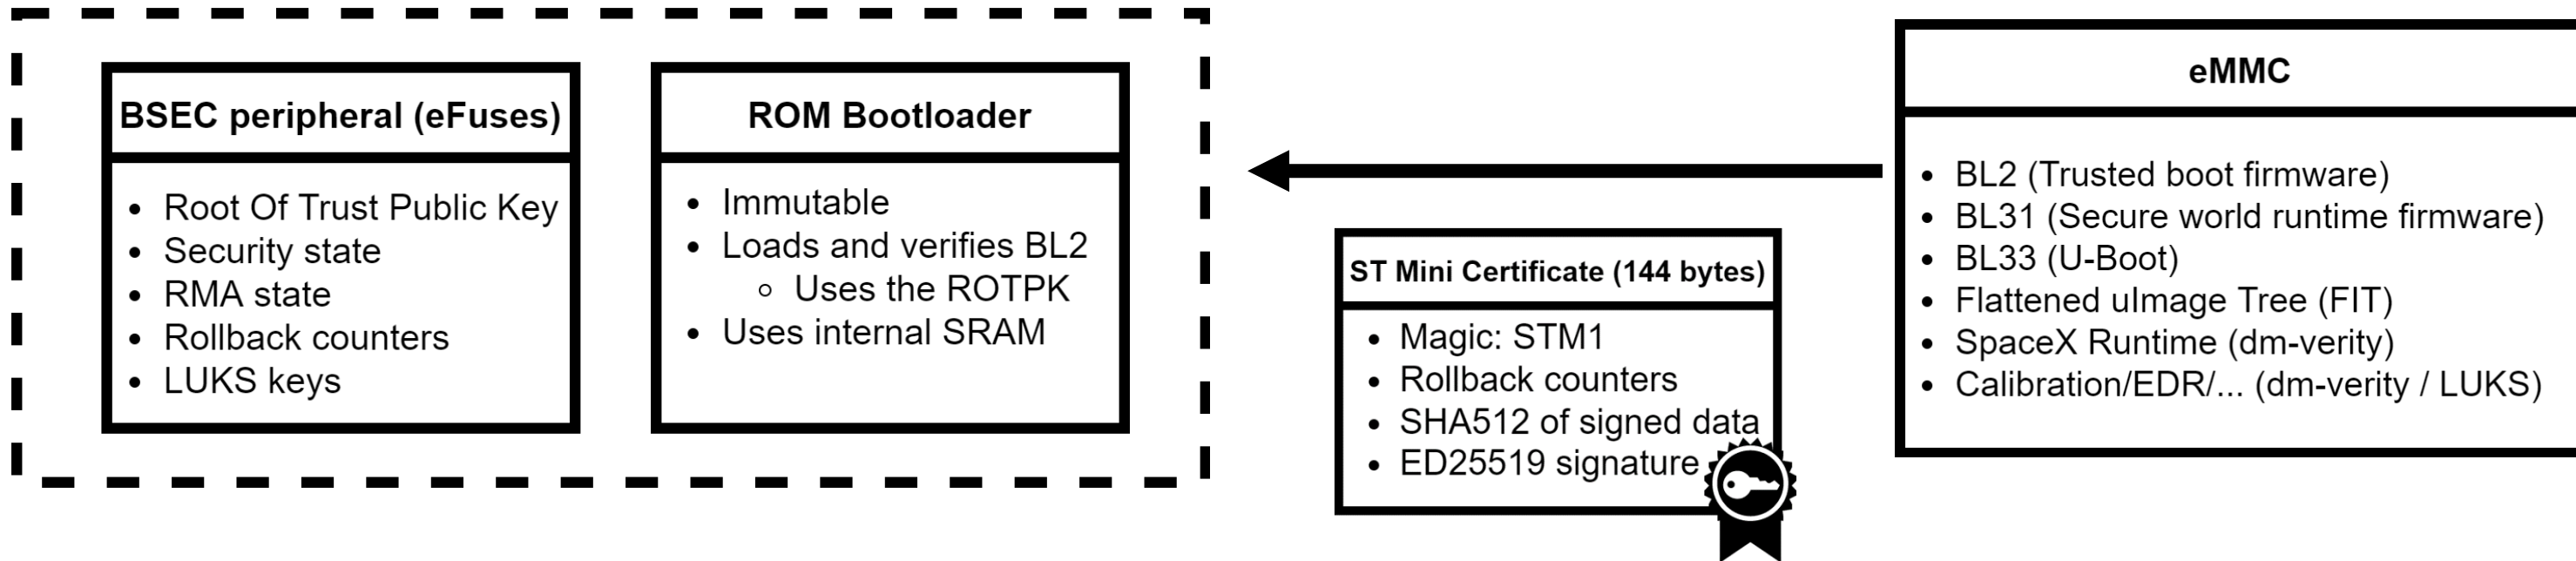
SoC Root of Trust

1. BL1 loads BL2 certificate from eMMC
2. BL1 verifies the certificate's signature

3. BL1 loads the BL2 firmware from eMMC
4. BL1 verifies that SHA512(BL2) matches the hash contained in the certificate

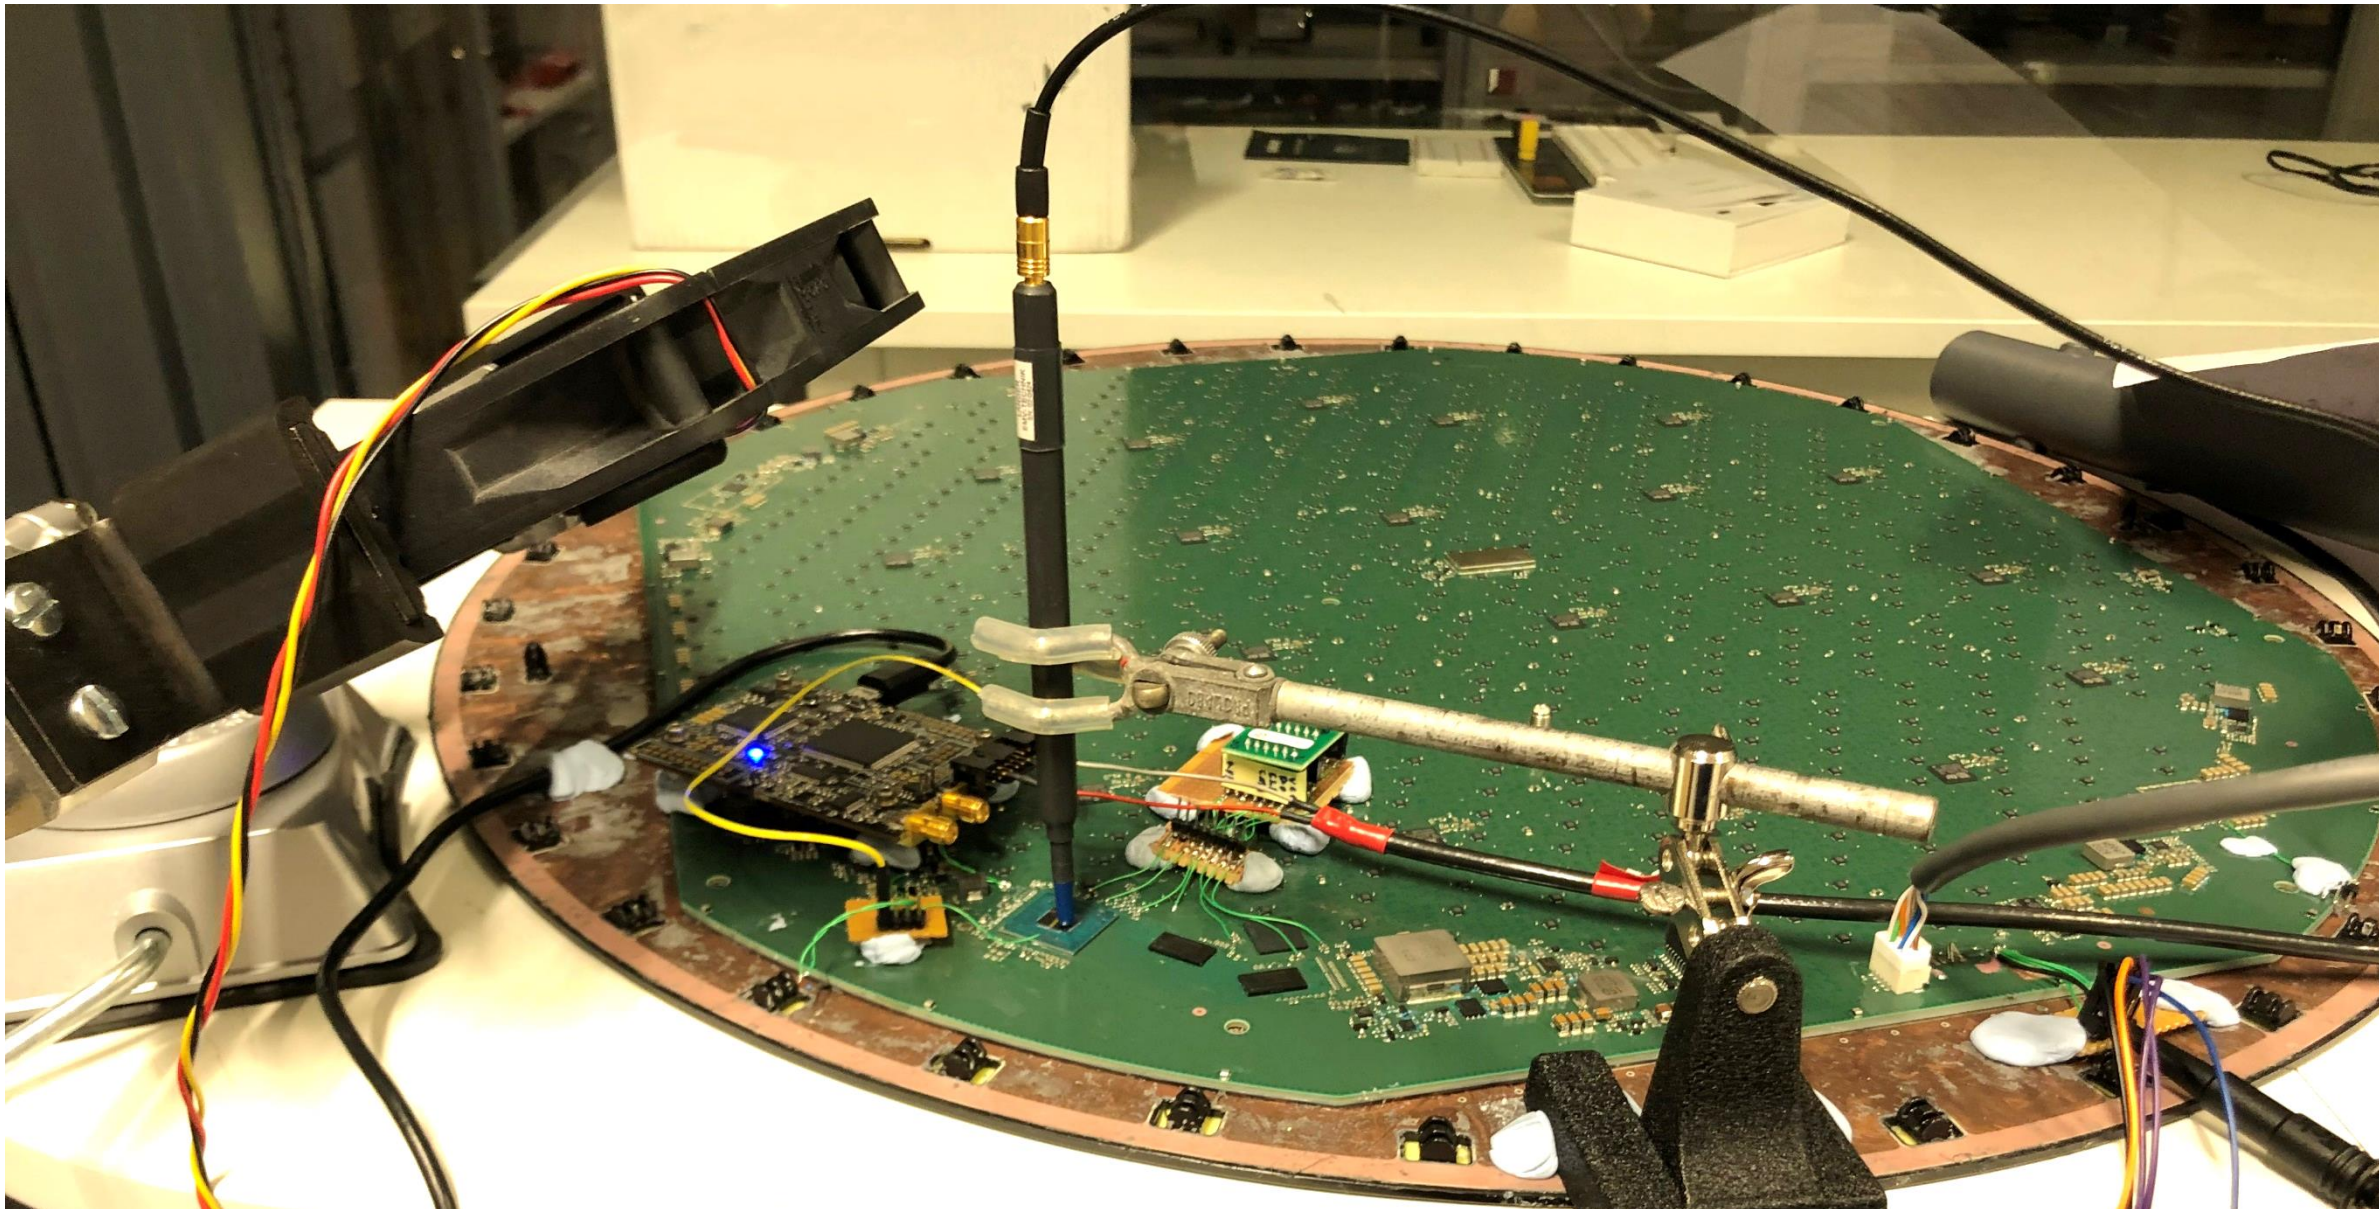
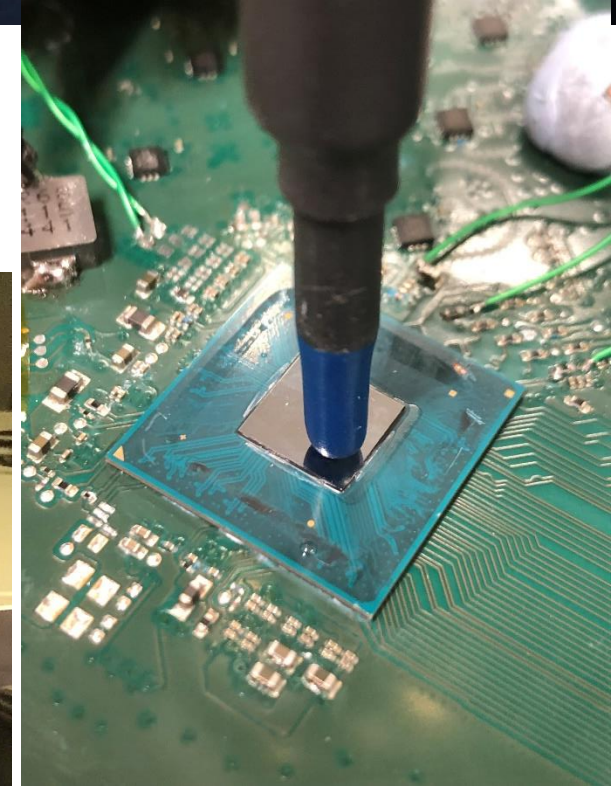
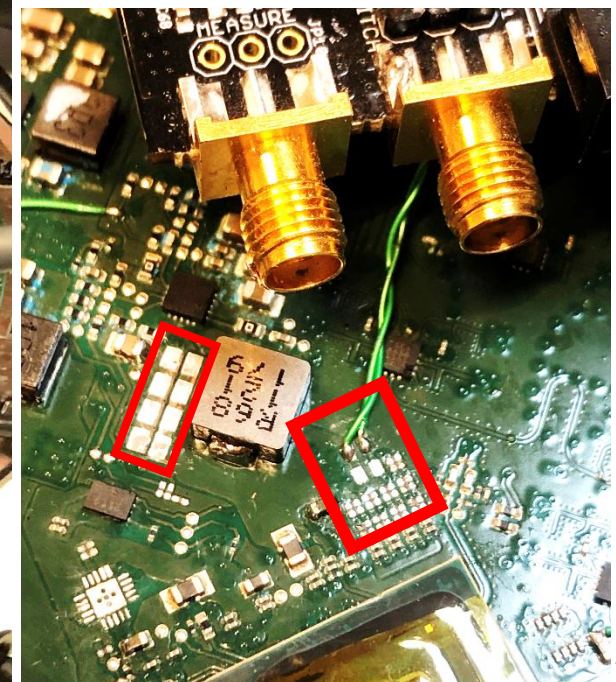
BL1 Glitch setup

- Try to boot with (in)valid signature, hash and firmware
- Try to glitch a valid certificate into a signature verification failure

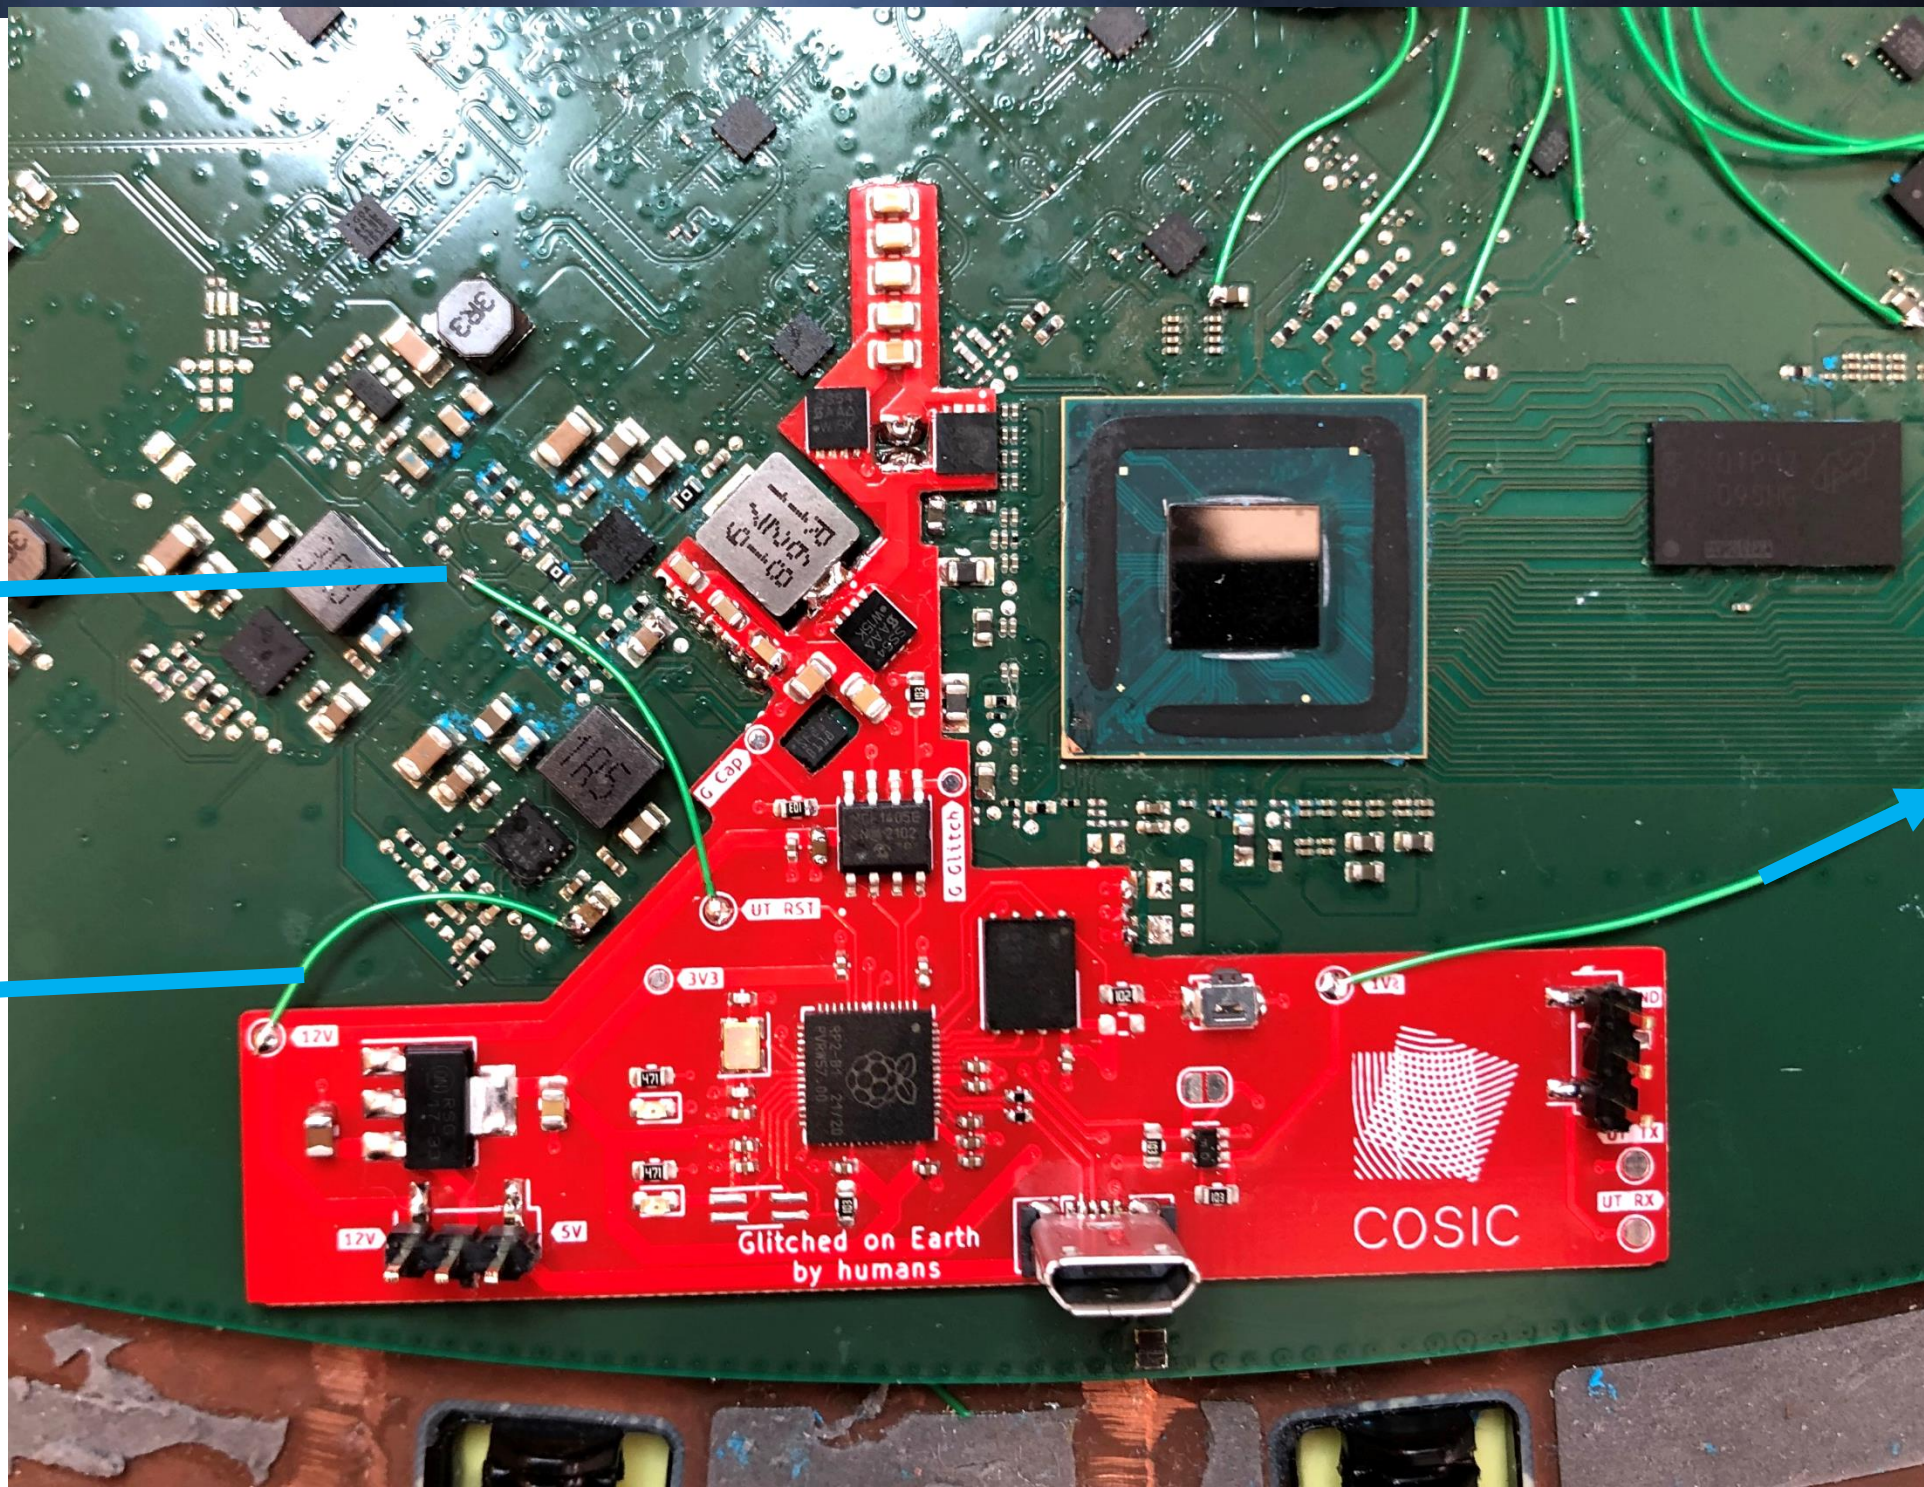
Installed modchip

Core voltage regulator
enable pin
(for power cycling)

12V for MOSFET drivers
and standalone power

1V8 for
level shifter

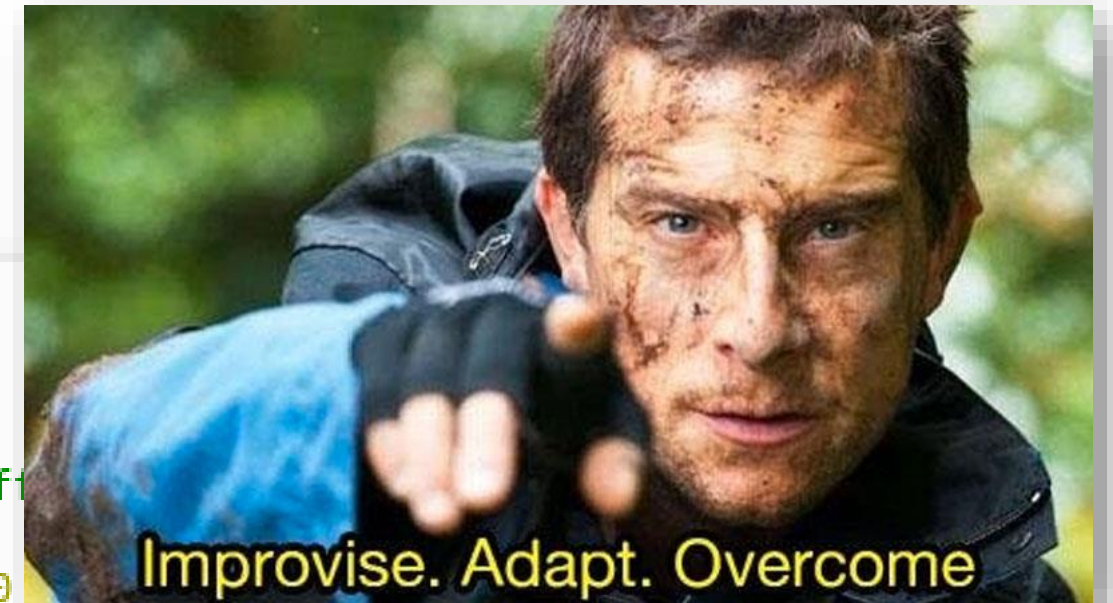
SpaceX strikes back

- I did a firmware update...
- Previously unused eFuse is now blown and disables UART output
- Modchip was designed to trigger on UART
