Glitched on Earth by Humans: A Black-Box Security Evaluation of the SpaceX Starlink User Terminal

Lennert Wouters

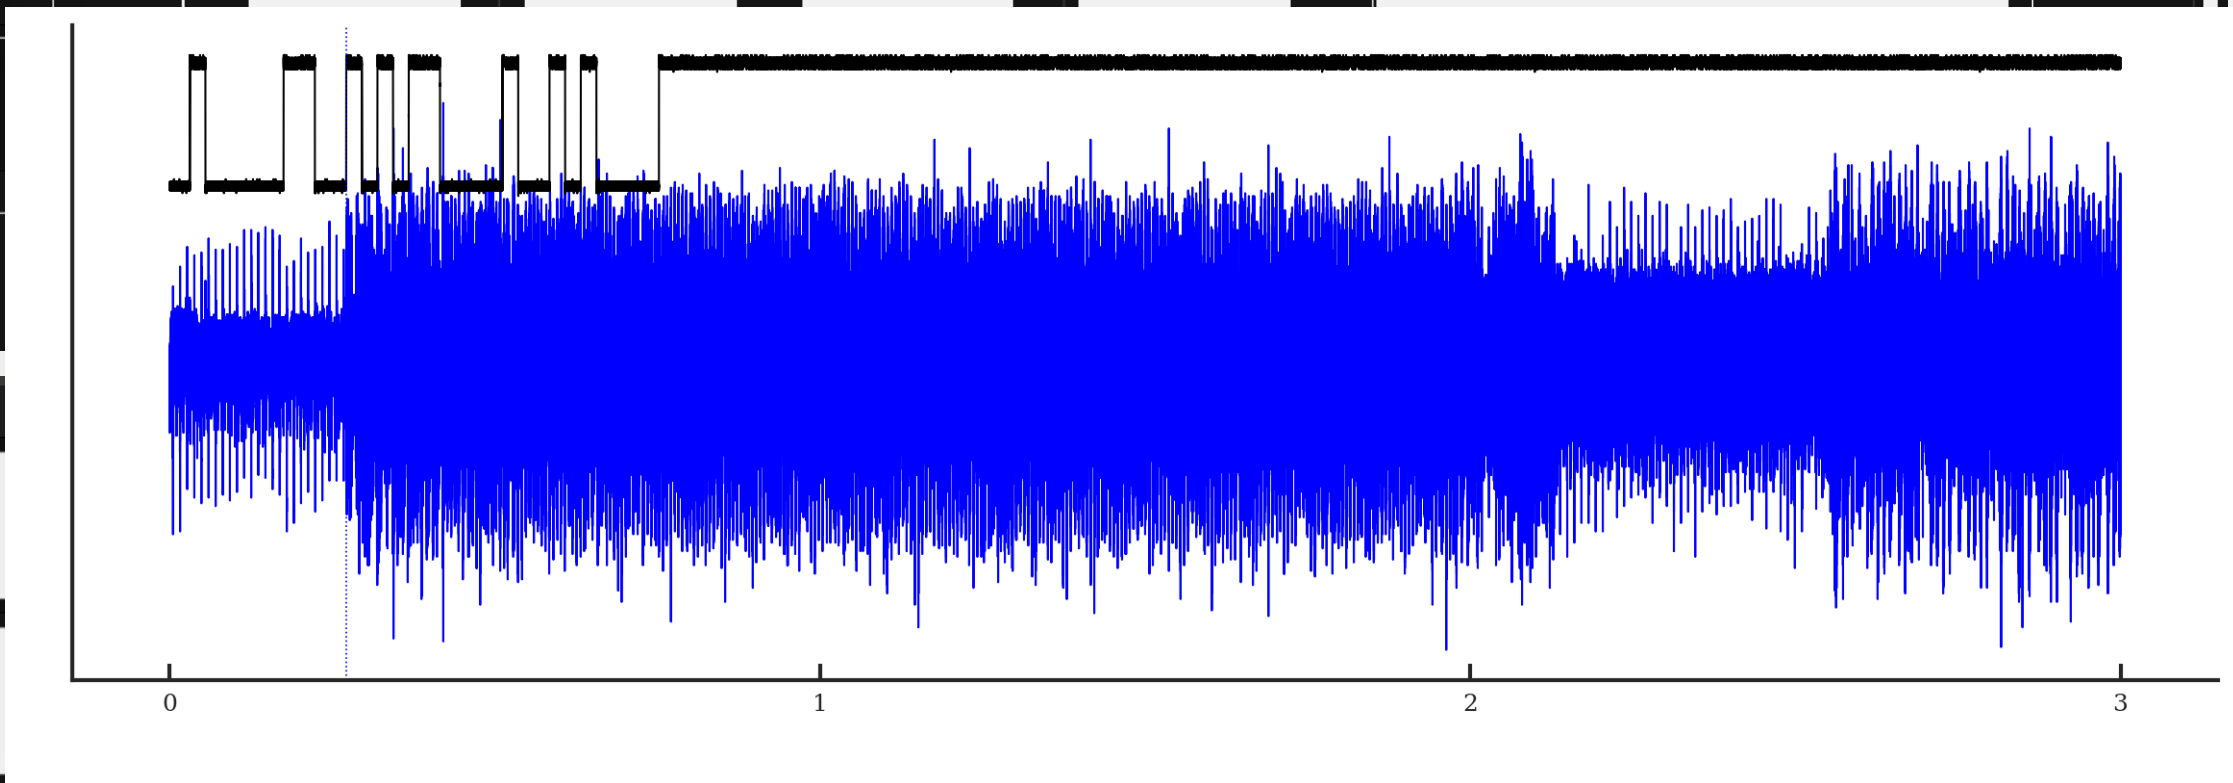
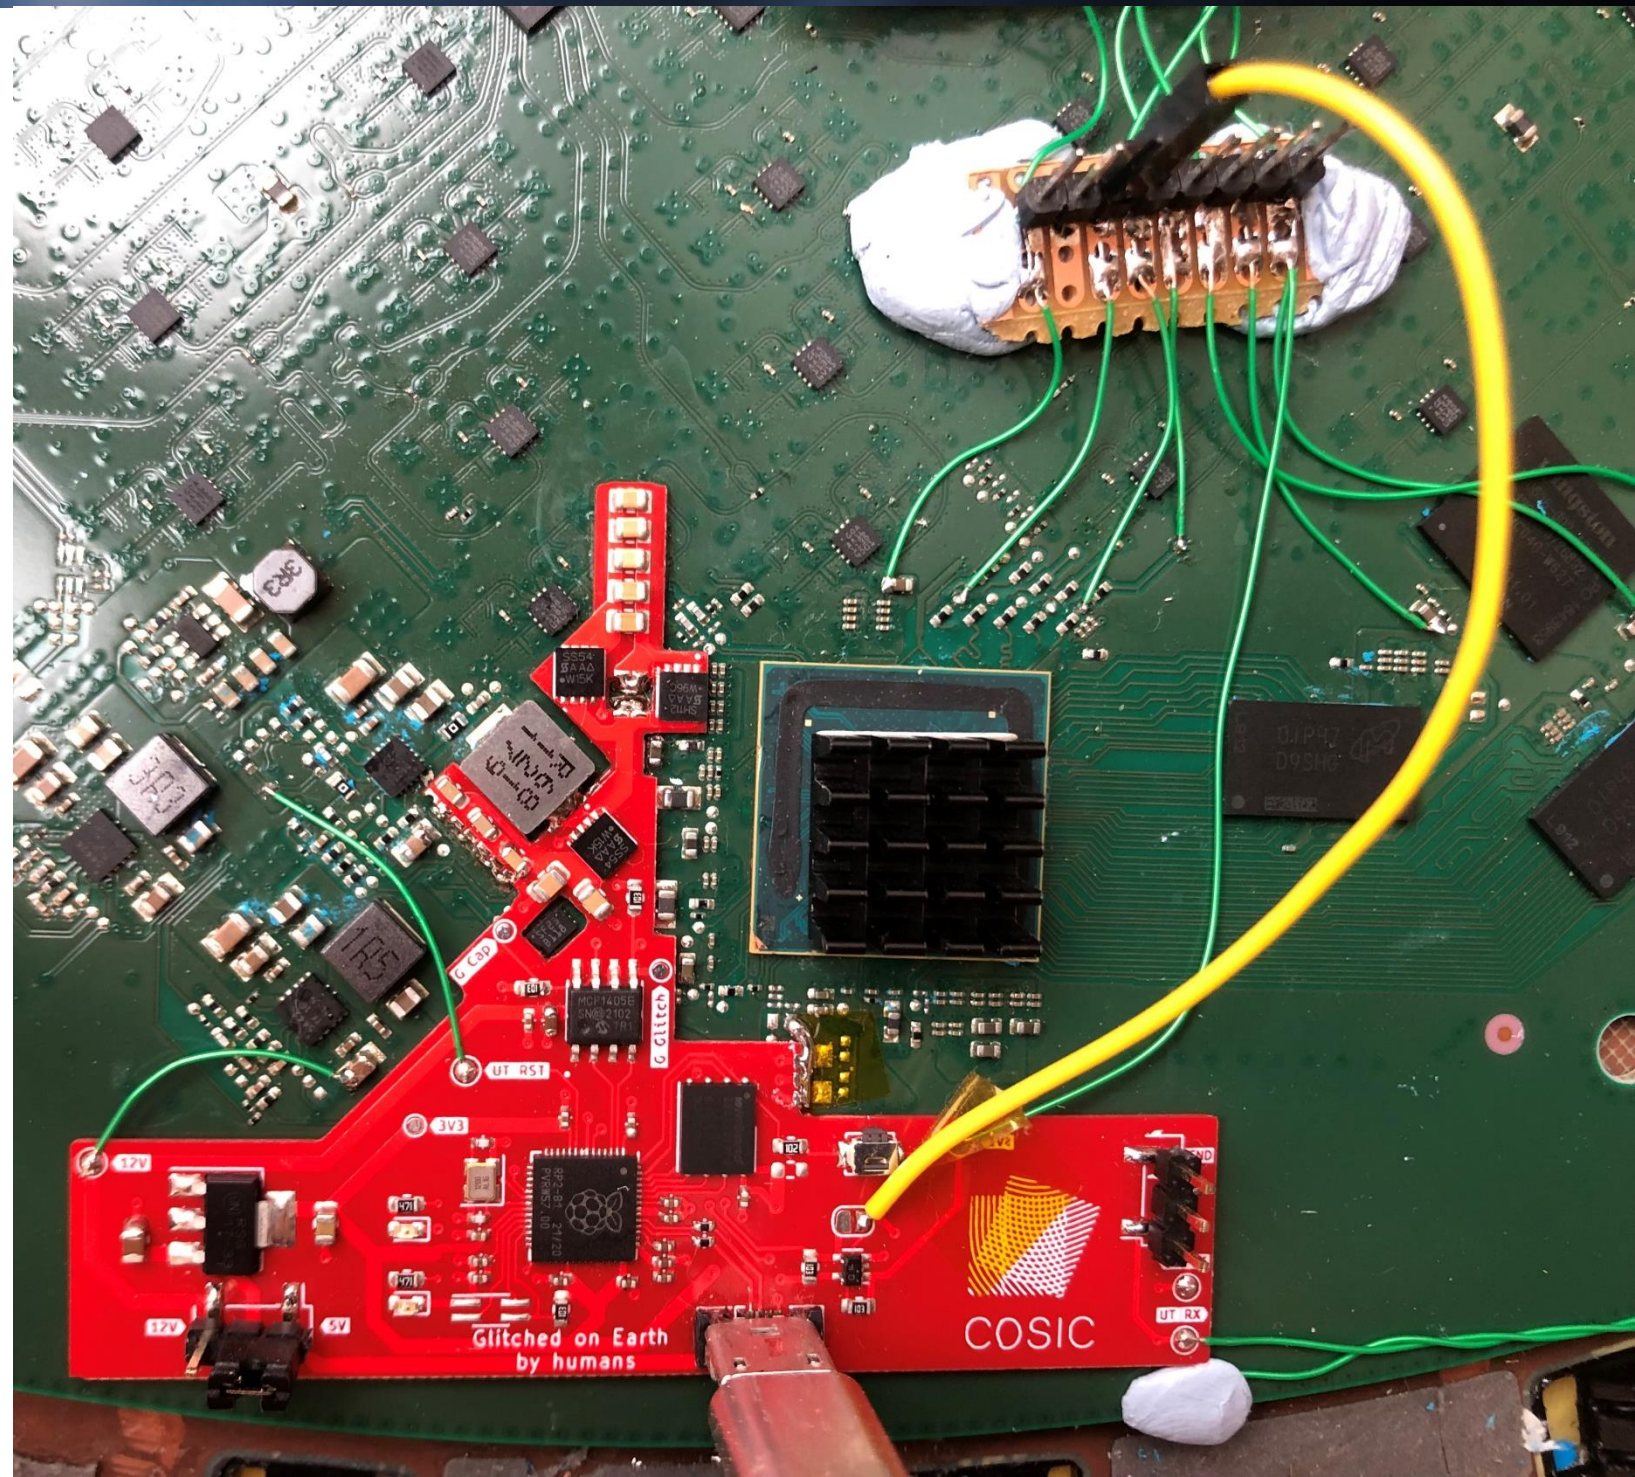
Adapt

- Trigger on eMMC D0 instead of UART
- Modchip could be easily adapted
 - Disconnect UT UART TX
 - Connect to eMMC D0
 - Update glitch parameters from Python
- Alternative: new PCB revision
